Potentially active faults in dam foundations

J. L. SHERARD,* L. S. CLUFF† and C. R. ALLEN‡

The Paper contains information on existing dams founded on active faults, a summary of pertinent lessons learned from study of historic fault breaks and fault mechanisms, recommended practice for evaluation of active faults, and opinions concerning design of dams on active faults. While a dam site with an active fault should be avoided if possible, if a reservoir is vitally needed and a better site is not available, it is reasonable practice to construct a conservatively designed embankment dam. Concrete dams on active faults, or near some major active faults, are not advisable. For evaluation of fault activity, geological studies usually must be carried a considerable distance from the dam site, a departure from recent past practice. Experience of the last few years with many fault studies indicates that thorough geological investigations with modern techniques will usually provide sufficient evidence to allow a judgement on the activity or inactivity of a fault.

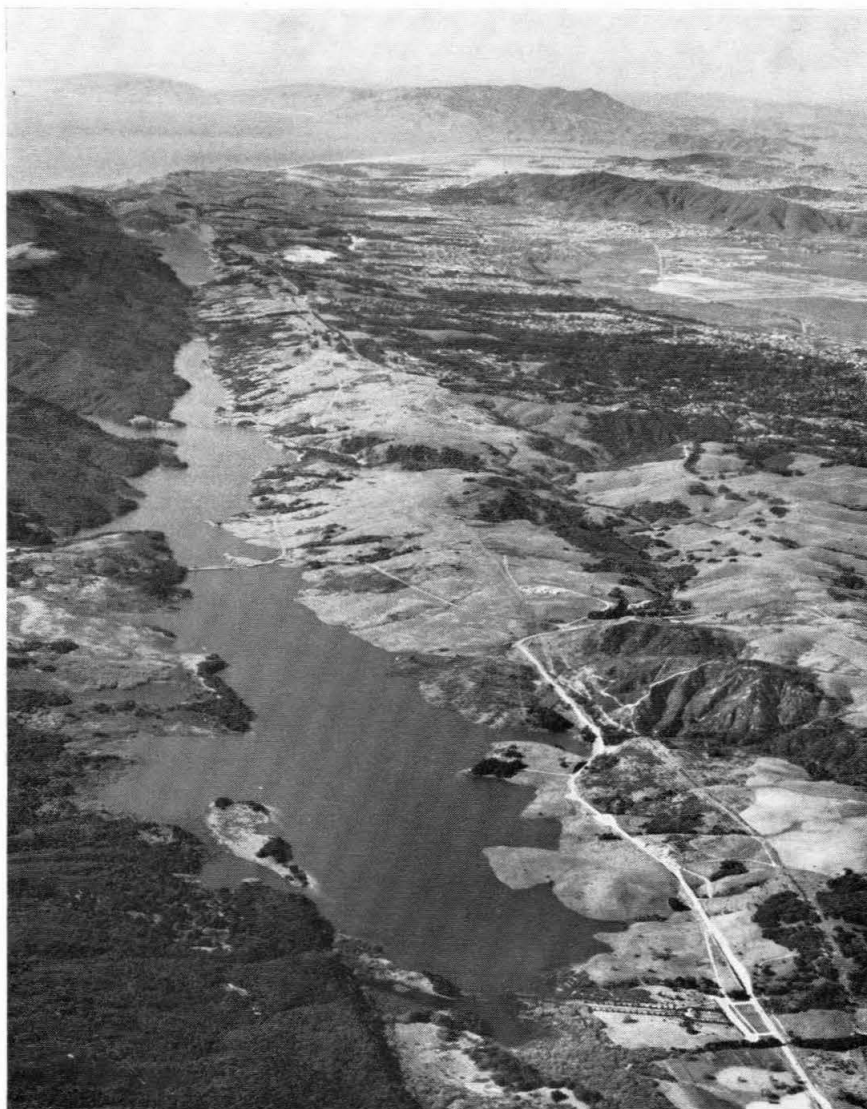
Fig. 2. Looking north along the main rift valley of the San Andreas Fault. The city of San Francisco is in upper right. Two reservoirs are shown in the fault valley; the San Andreas Reservoir in the distance and the Crystal Springs Reservoir in the foreground. The 1906 fault break went up the valley through the centre of both reservoirs. The embankment of the old Upper Crystal Springs Dam (now serving as a highway) offset in 1906 is shown running across the Crystal Springs Reservoir in the centre. The valley is typical of fault valleys of 'master', strike-slip faults seen in many parts of the world (see also Figs 10, 19, 22, and 25)

From a statistical point of view this experience is a special case because the dam was constructed directly across the main fault valley of the major San Andreas Fault (Fig. 2). It was done more than 100 years ago at a time when very little was known about earthquakes and faulting. At the present state of knowledge such major faults as the San Andreas can be easily recognized as active faults, and the fault valley would not generally have been considered a suitable dam site.

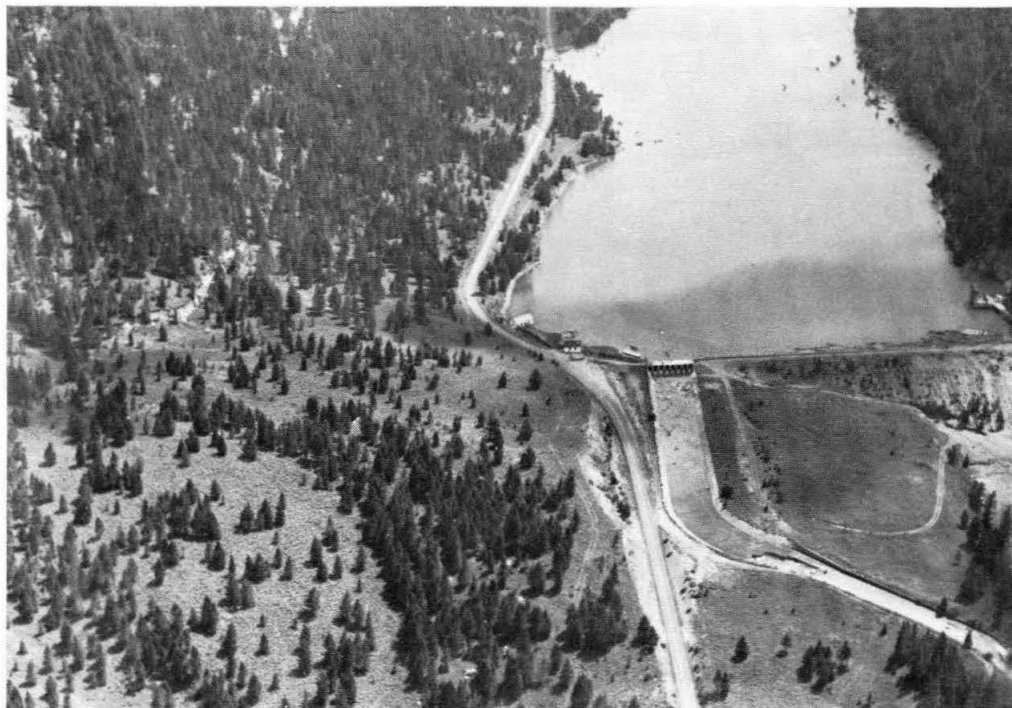
Fig. 6. Looking upstream with Hebgen Dam in foreground, three days after the earthquake. The main Hebgen Fault break is clearly visible in the trees running along the valley wall parallel to the lakeshore on the left side of the photograph

The second example of a 'near miss' was at the Hebgen Dam, Montana, during the West Yellowstone earthquake of 17 August 1959 ($M=7.1$). The 27 m high, 210 m long earth dam, constructed in 1914, retained a 370 million m^3 reservoir with a length of about 25 km. The reservoir was full at the time of the earthquake. Movements occurred on a number of major faults with primarily vertical displacement (Fig. 5). The aggregate length of all the main fault breaks was more than 75 km. The main Hebgen Fault break traversing the north wall of the reservoir, about 200 m from the right end of the dam had a vertical displacement of about 5 m at this point, with the north side of the fault going up relative to the south side (Figs 6–8).

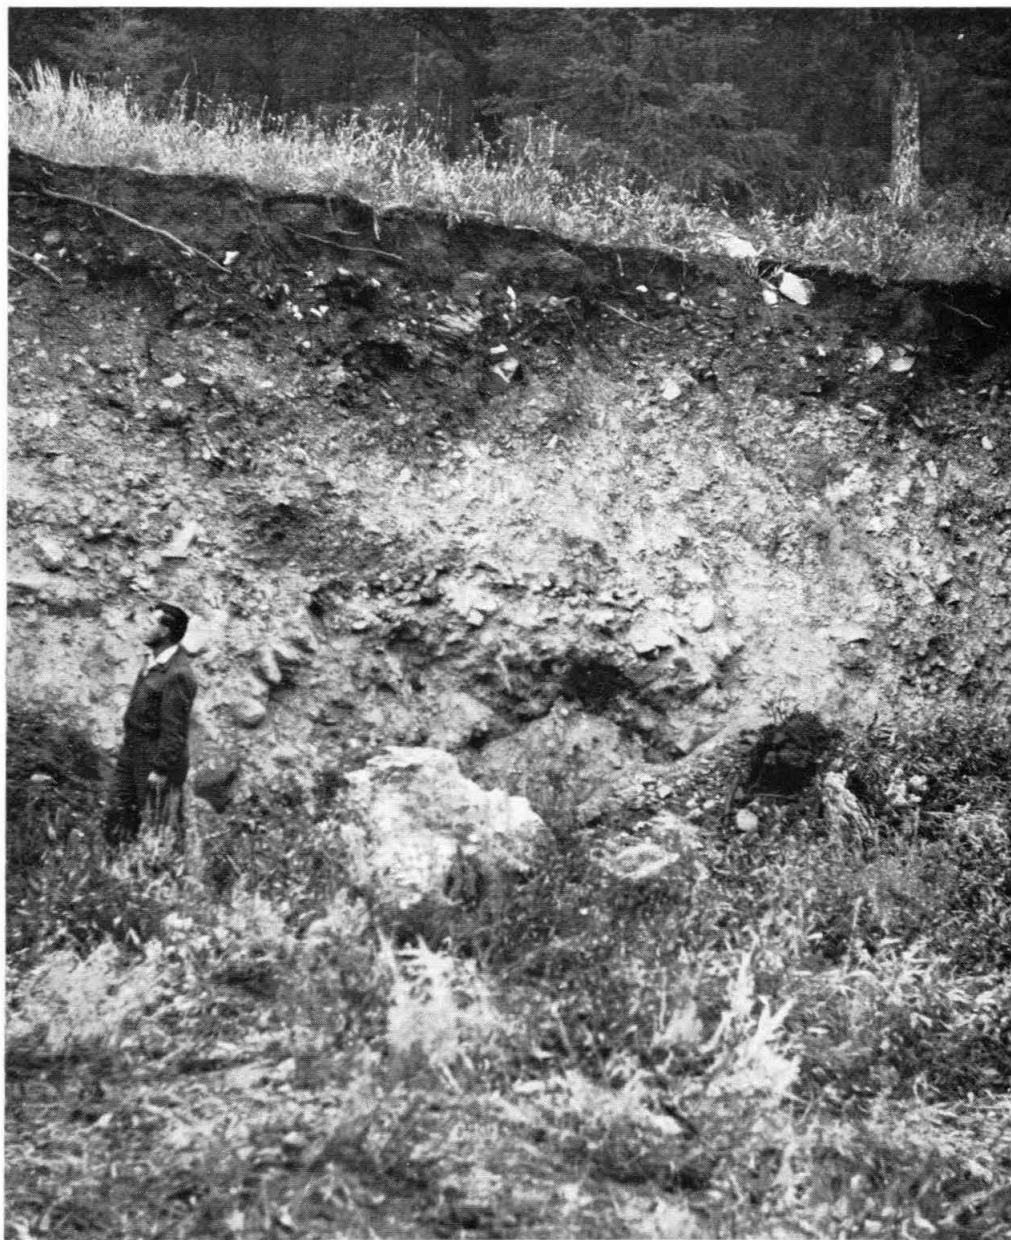
Fig. 7. Break on Hebgen Fault directly opposite dam; approximately 5 m vertical displacement

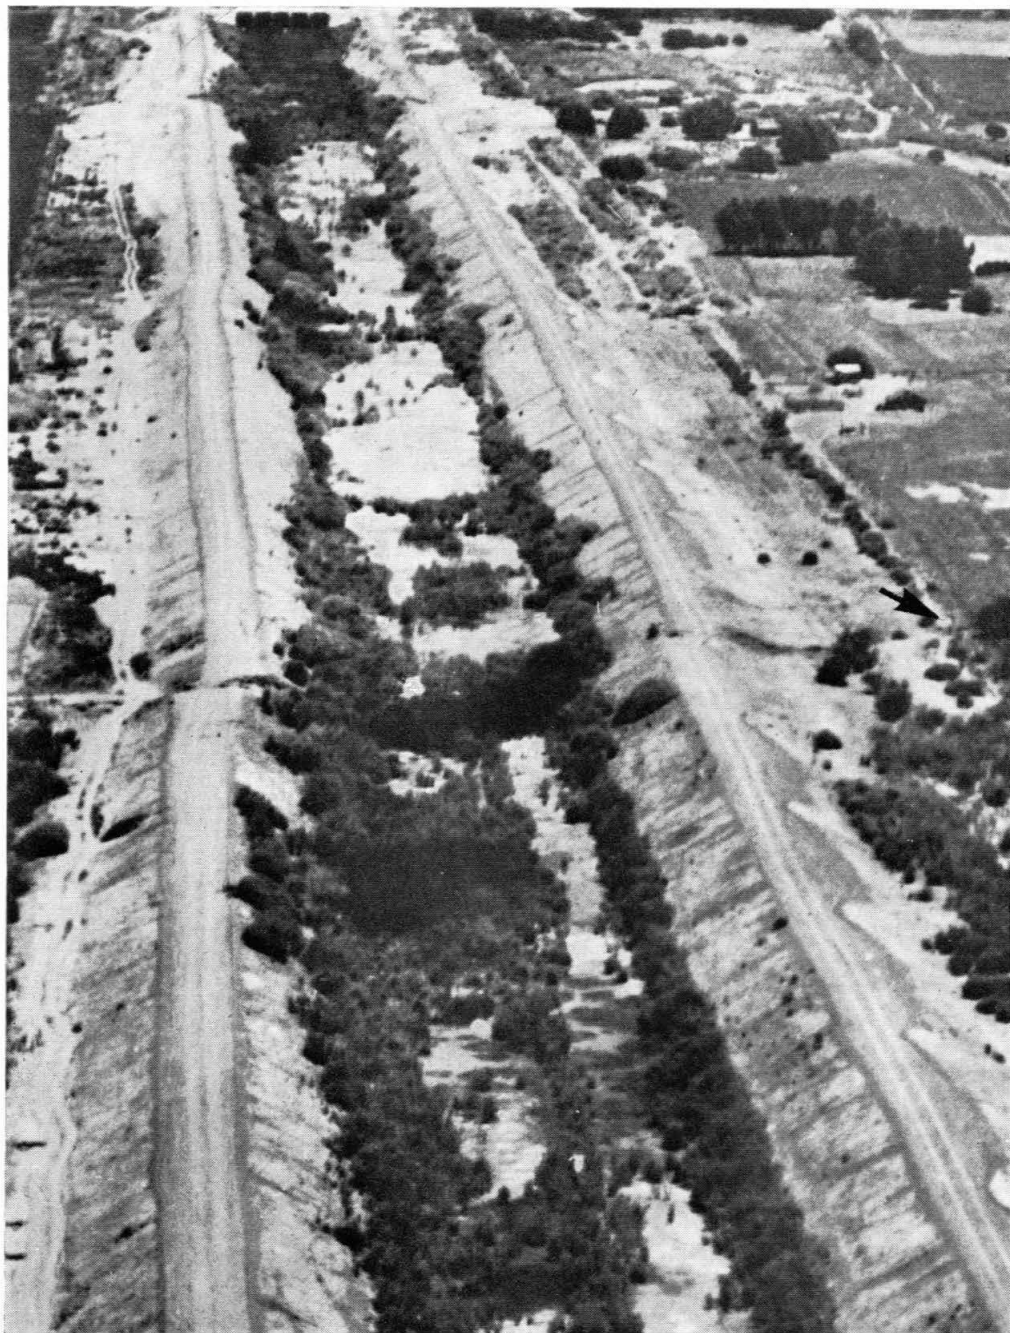
Fig. 9. Break on the Imperial Fault displaced the All-American Canal during the 1940 El Centro earthquake ($M=6.7$). The fault offset was nearly completely horizontal (strike-slip), approximately 4.3 m. The canal was nearing completion of construction but not carrying water at the time of the earthquake. Note that the fractured zone between offset canal embankments is relatively narrow

Figure 9 shows the resulting fault breaks through a large canal in 1940, illustrating particularly that for breaks on strike-slip faults (with primarily horizontal movement) the zone of fracturing is limited to a relatively narrow zone.

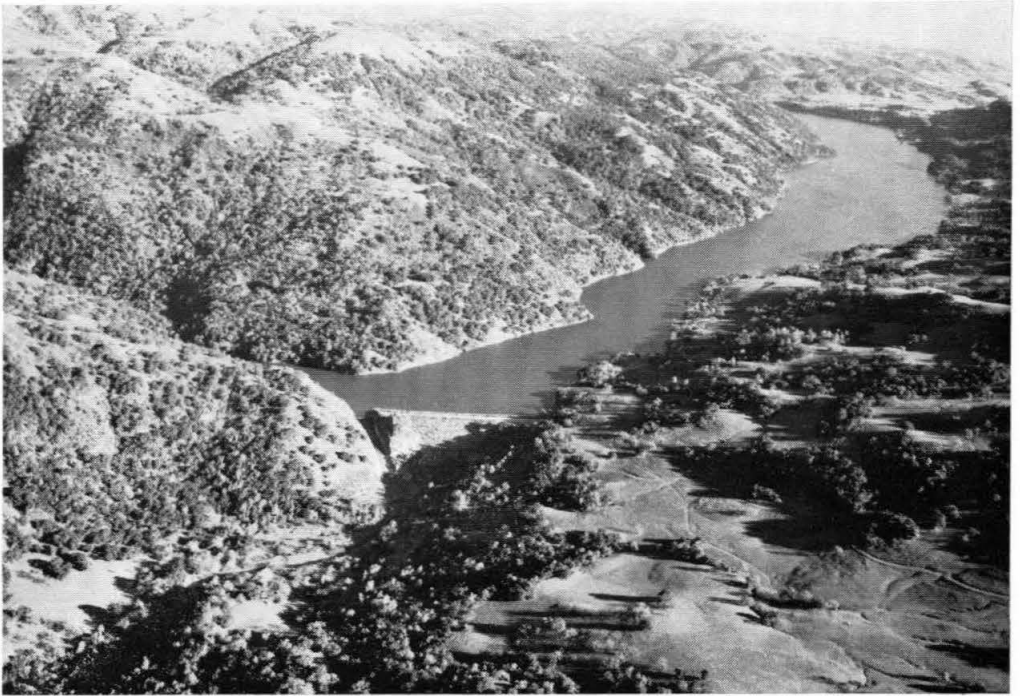
Fig. 10. 38 m high Coyote Dam built across the rift valley of the Calaveras Fault, California. Note typical narrow valley of strike-slip fault

The 38 m high Coyote Dam, retaining a 30 million m³ reservoir, was constructed in 1936 near San Jose, California, at a site where the foundation is underlain by the main branch of

the Calaveras Fault (Fig. 10). The nearby Hayward Fault broke last in 1868 causing an earthquake with a probable magnitude of 6.5 to 7.0.

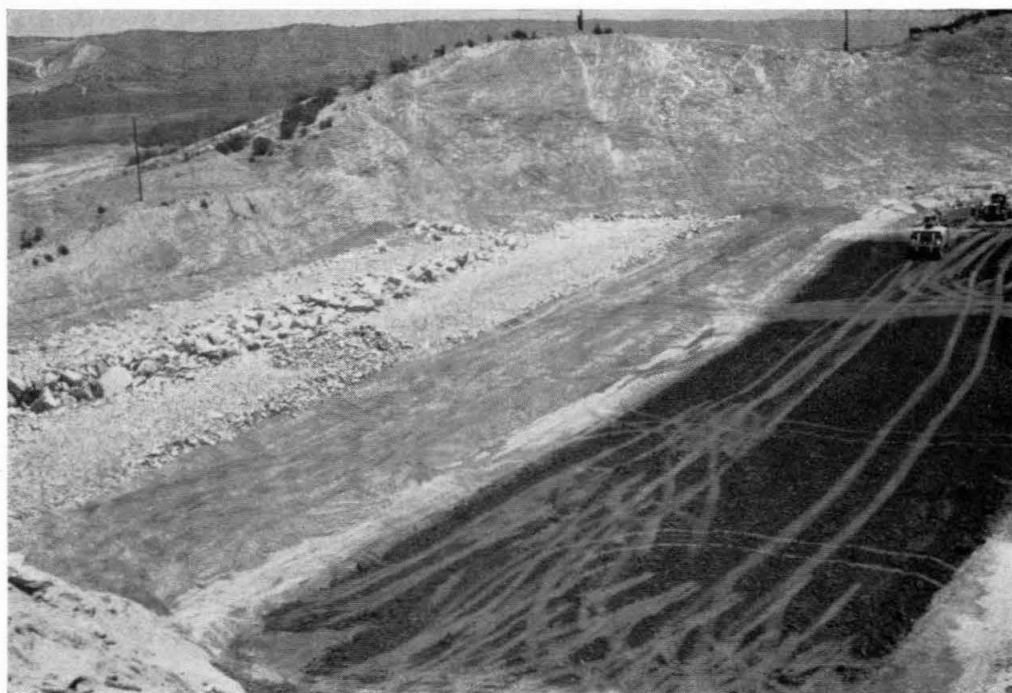
Fig. 15. Cedar Springs Dam during construction, looking downstream showing core at right and zones 2, 3, 4 and 5 progressively downstream

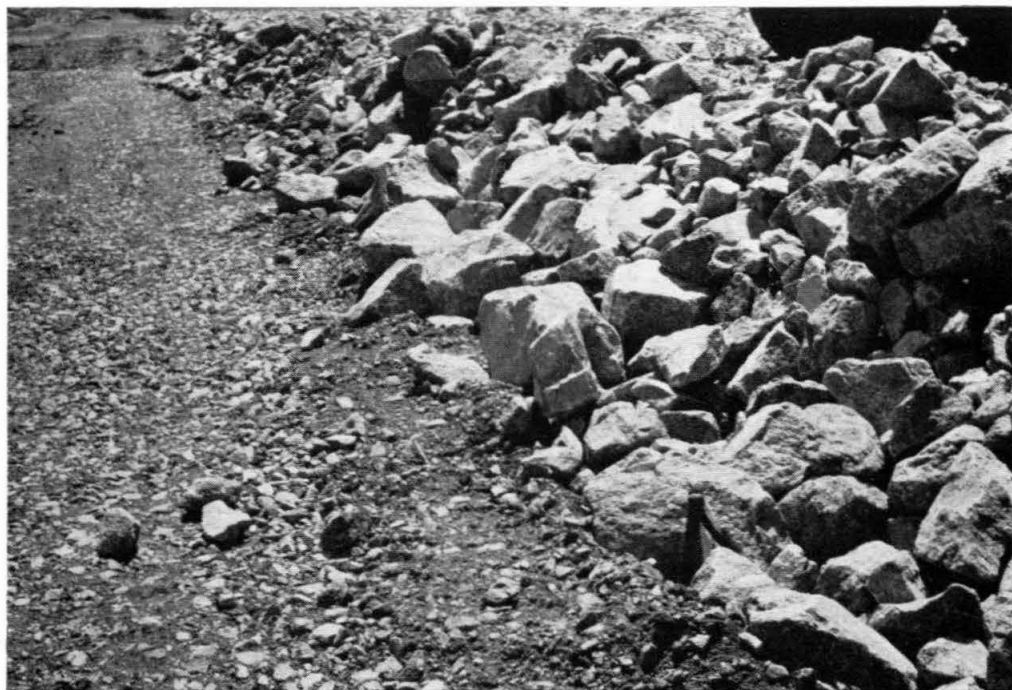
Fig. 16. Cedar Springs Dam during construction, looking at the boundary between transition zone 3 and downstream rockfill zone 4. It is apparent that the permeability of rockfill zone 4 is several orders greater than that of zone 3

typical view during construction of the juncture between zones 3 and 4 of the downstream shell, which gives confidence that any amount of water that could get through the zone 3 material would percolate away into the downstream rockfill safely.

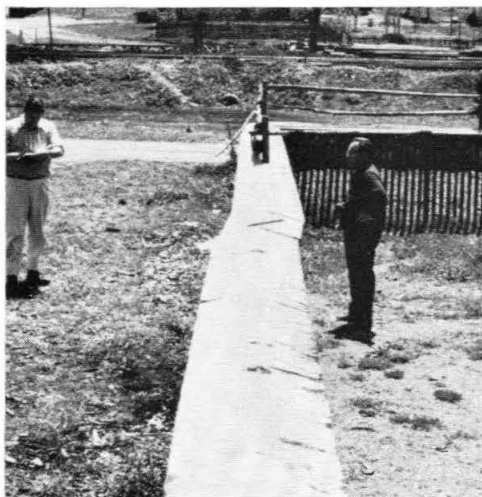
Fig. 20. Horizontal offset of wall by creep along North Anatolian Fault, Ismetpasa, Turkey. It is reported that creep is progressing at 1–2 cm/year since the photographs were taken in 1969 (Nason, 1972). During the 1944 Bolu earthquake ($M=7.6$) 1.5 m of horizontal displacement took place at this same location

fault creep—has recently been recognized in several parts of the world (Fig. 20). Furthermore, it is now known that earthquakes resulting from displacement and energy release on one fault can sometimes trigger small displacements on other unrelated faults many kilometres distant.

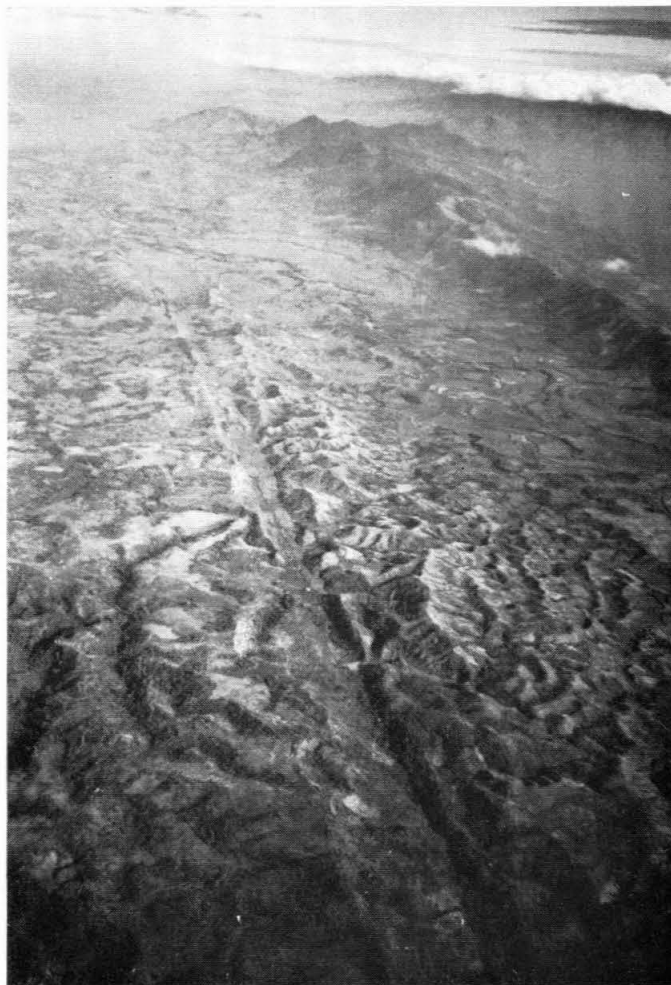
Fig. 22. Philippine Fault in northern Leyte: master strike-slip fault of more than 1000 km length. Note tendency of streams to erode along the fault valley. No historic displacements are known along this segment of the fault, but a 3.2 m displacement occurred on the fault 400 km further north, during the 1973 Ragay Gulf earthquake (Morante and Allen, 1973)

Strike-slip faults. These involve primarily horizontal displacements. The fault planes are typically near vertical and are markedly linear in plan view, master faults of this type often appearing as linear 'scars' on aerial photographs (Figs 22 and 23).

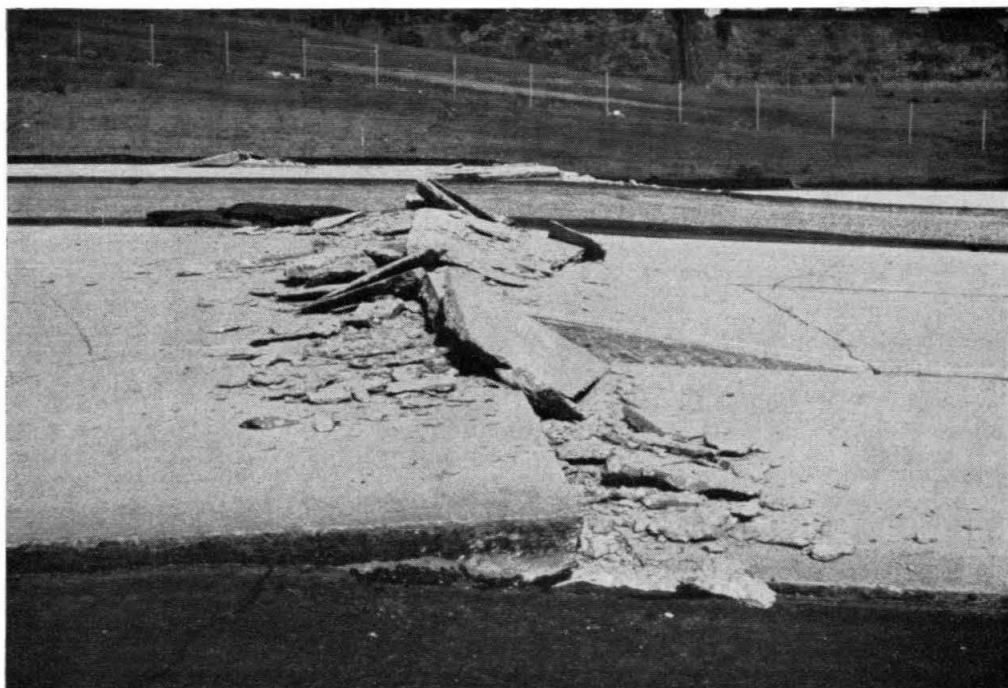
Fig. 24. 1971 San Fernando, California thrust fault break passing through concrete pavement showing buckling resulting from shortening of a distance between points on opposite sides

Thrust faults. These involve vertical displacements caused by horizontal compression. The distance between points on opposite sides of the fault decreases as a result of the displacement (Fig. 24). The fault planes tend to have a shallow inclination (dip) from the horizontal—typically 20–40°. Because of the shallow dip, thrust fault traces tend to be sinuous in plan view through hilly terrain. Many major mountain systems of the world are bounded by thrust faults, such as the Andes and Himalayas, and most of the world's great earthquakes have been caused by thrusting in the oceanic trenches where the ocean floor is being thrust beneath the continental edges. The great 1964 Alaska earthquake and the 1960 Chile earthquake are typical results of breaks on such fault systems.

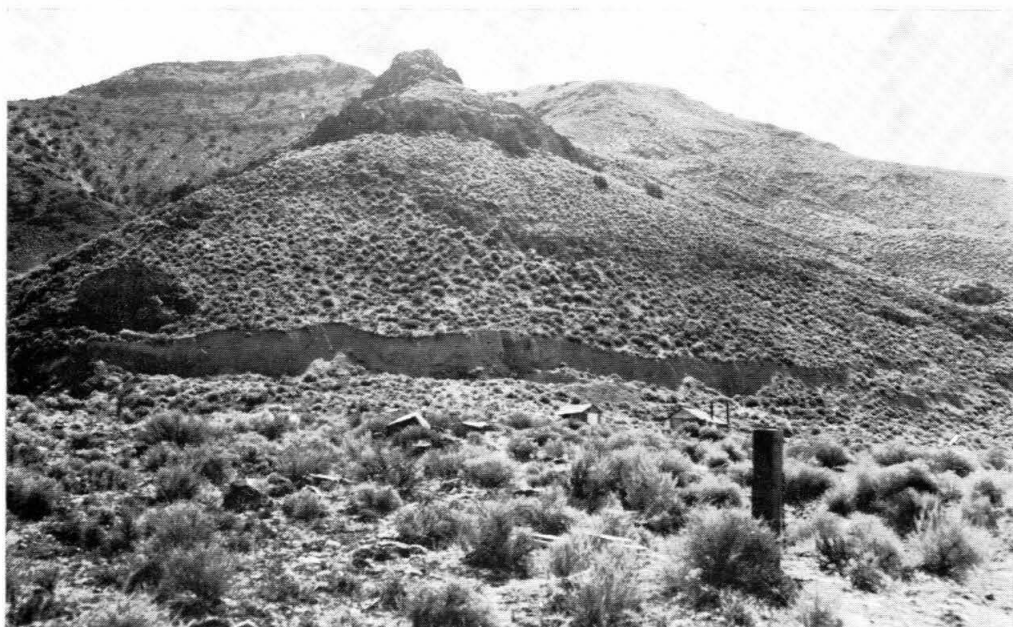
Fig. 25. 1963 photograph of 1915 break on the Pleasant Valley Fault (normal fault) Nevada. Fault scarp is exceptionally well preserved in the arid climate

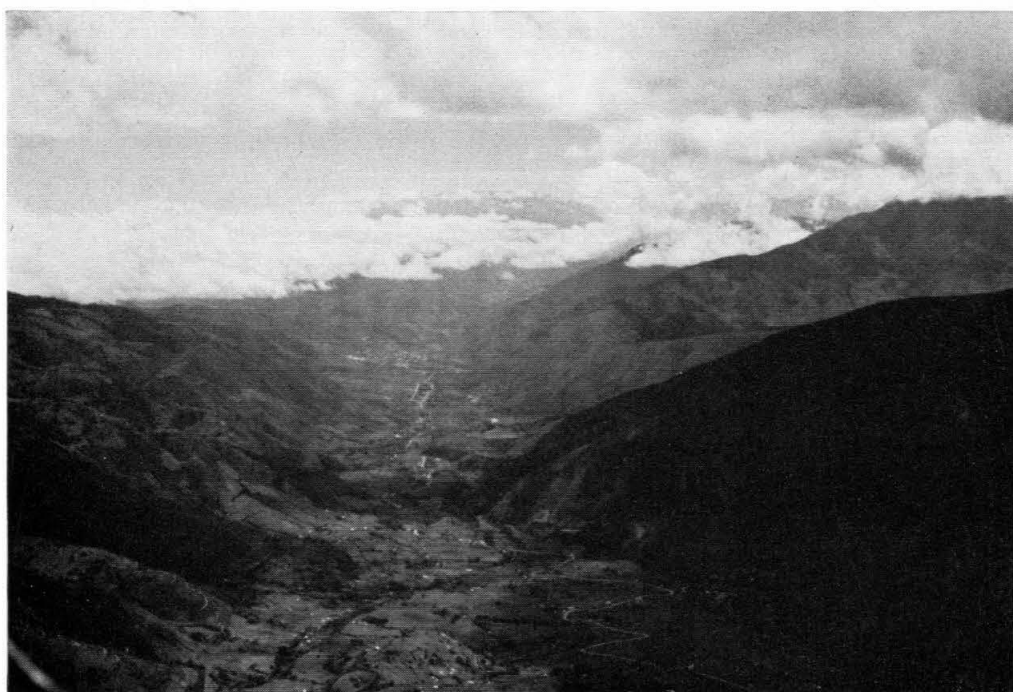
Fig. 26. Main rift valley of Boconó Fault, Venezuela (master strike-slip fault) with length of at least 500 km, looking northeast from Lagrita towards Merida in the far distance

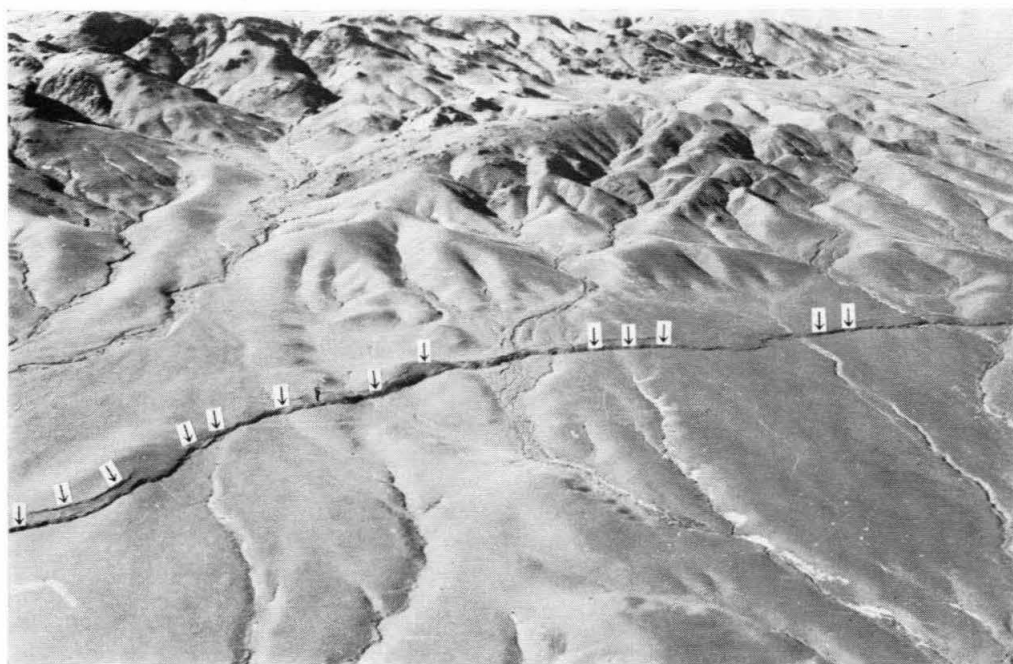
Fig. 30. Scarp (arrows) of 1957 Gobi-Altai earthquake ($M=8.3$) in Mongolia. Average fault break displacement in area of photograph was 5 m horizontal component and 5 m thrust component

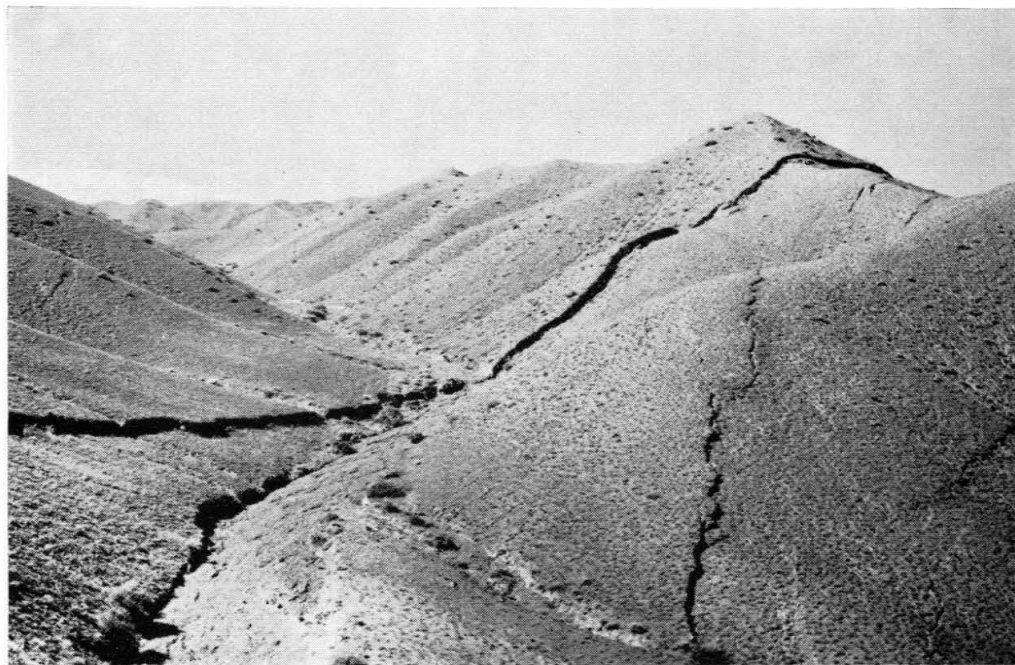
Fig. 33. Break on a secondary normal fault with a displacement of about 1.0 m during the 1957 Gobi-Altai earthquake, Mongolia ($M=8.3$). Several branch faults are broken on the downthrown block

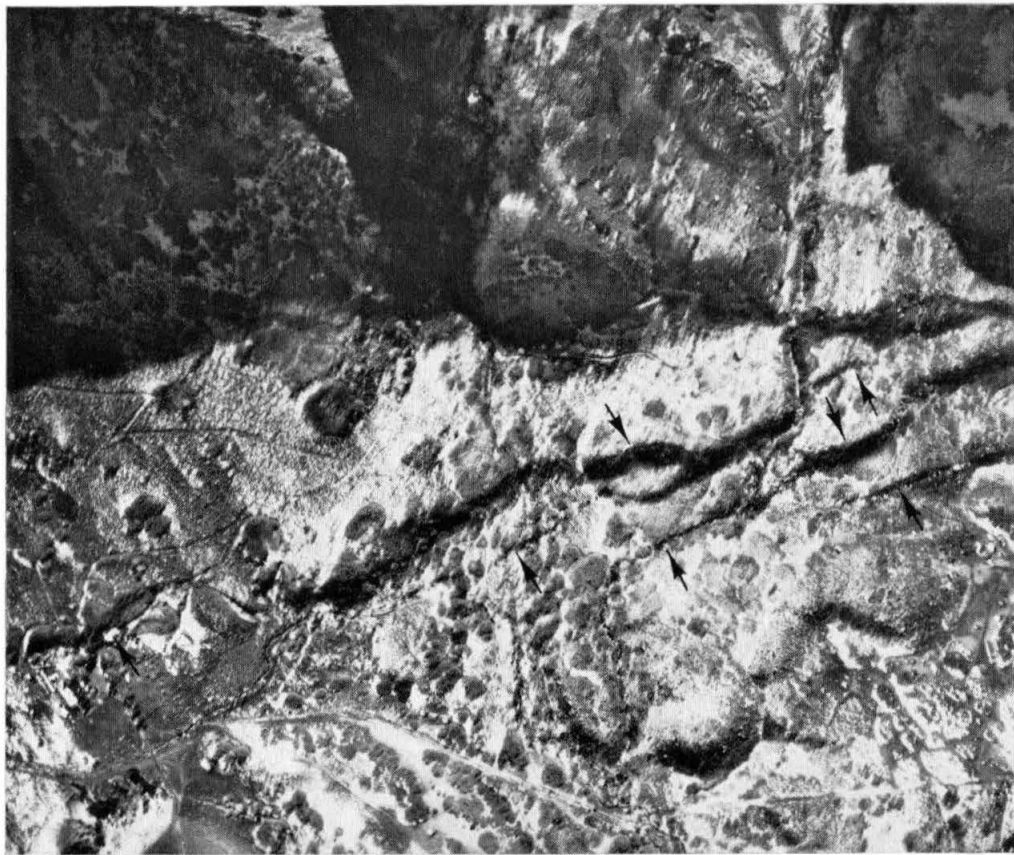
Fig. 38. Conventional air photograph showing a section of the main Wasatch Fault in central Utah, a 'master' normal fault which has not broken in historic time but is obviously active from much geologic evidence. The fault is shown by the black arrows (after Cluff and Slemmons, 1972)

Figures 38 and 39 illustrate the effectiveness of low sun angle photography during studies of the major active (normal) fault which bounds the west edge of the Wasatch Mountains, at a

site near Salt Lake City, Utah. Fig. 38 is a conventional vertical photograph of a section of the fault. Fig. 39 is a vertical photograph of the area outlined in Fig. 38. Fig. 38 was taken at approximately midday. Fig. 39 was taken at approximately 09.00 h, catching longer shadows. The example of Figs 38 and 39 is not extreme. In some cases, ordinary photographs may show almost no evidence, whereas the faults stand out clearly on low sun angle photographs (Fig. 40).

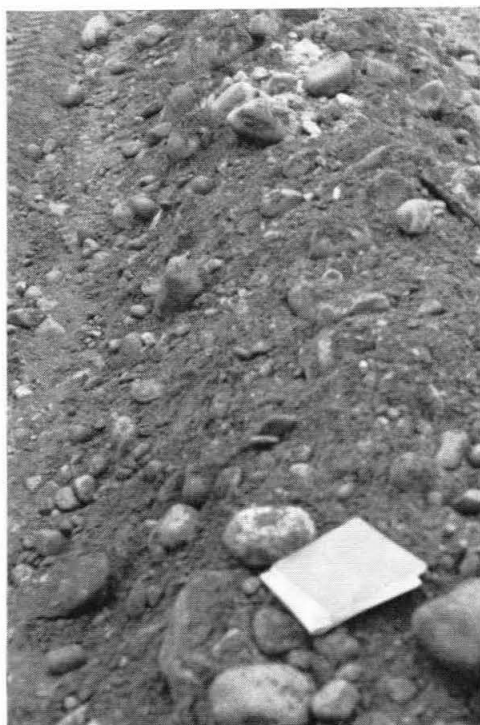
Fig. 47. Typical natural alluvial sand-gravel mixture meeting the gradation of Fig. 46. Thick zones of material of this general nature, used without processing, constitute good, self-healing and internally stable transitions
